## ROTOR DYNAMIC MODELLING AS A POWERFUL SUPPORT TOOL FOR VIBRATION ANALYSIS ON LARGE TURBOMACHINERY

### ABSTRACT

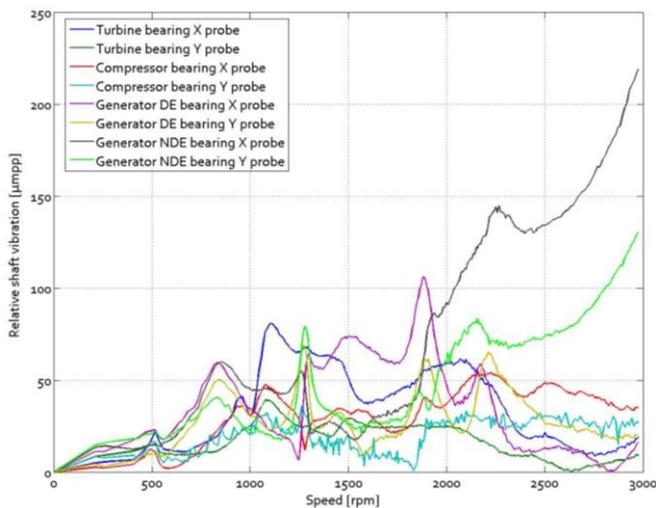
During several attempts to start up the unit one didn't succeed to reach nominal speed due to automatic shutdowns at  $\pm 2980$ rpm caused by high relative shaft vibrations ( $>200 \mu\text{m}_{pp}$ ) at the generator exciter end bearing (Figure 1).

Figure 1: Relative shaft vibration amplitudes during startup

From the vibration data it seemed that the shaft line was exhibiting the influence of a lateral critical speed near 3000rpm. However, this lateral mode was never observed or measured into detail earlier, also not on similar units within the fleet. It was decided to define a balancing correction as a first urgent action. On-site balancing of a generator rotor is difficult because it is very time consuming to have access to the balancing planes at the rotor ends. Therefore, the existing

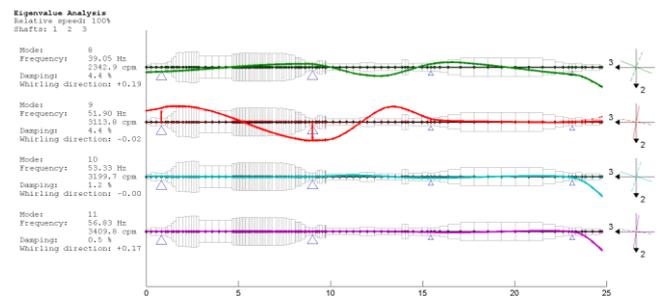
From the calculated eigenvalues at 50Hz two modes seemed to be present near the operating speed of the shaft line (Figure 3). The closest modes influencing the dynamic behaviour are at respectively 51.9Hz and 53.3Hz. The first eigenmode is the second vertical bending mode of the gas turbine and is unlikely to be causing high vibrations near the generator shaft end. The second eigenmode is a horizontal bending mode of the shaft end. From the eigenvalue analysis it is clear that the damping factor is poor and the mode deformation is almost completely planar (whirling factor of 0). This mode shape is shown in Figure 4 and shows clearly the planar deformation near the shaft end.

Figure 3: Eigenvalue analysis of the shaft line

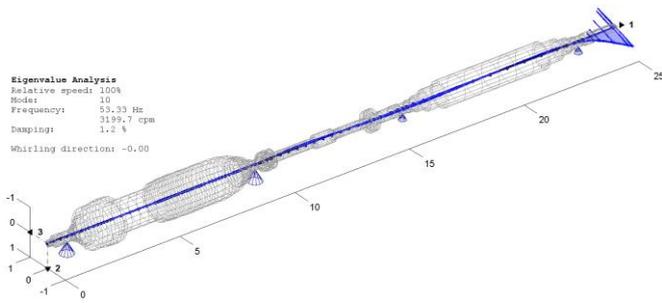
**Figure 4: 3D mode shape of the bending critical of the shaft end**

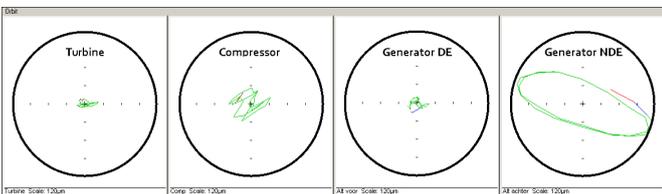
Based on the measured direct orbit shapes it was possible to conclude that it was this shaft end mode that was responsible for the high shaft vibrations causing the automatic shutdown of the unit during startup (Figure 5). One can clearly see that there is a local horizontal deformation at the generator NDE measuring plane near nominal speed, but for all the other measuring planes the relative shaft vibration amplitudes remain rather low.

**Figure 5: Direct orbit plots at 2980rpm**

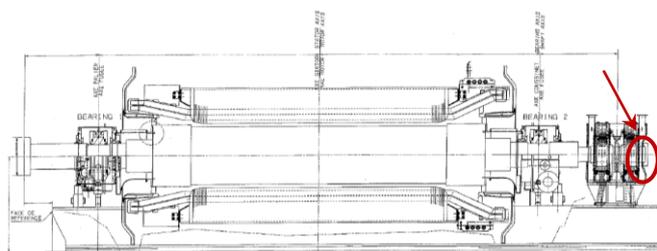
**Figure 6: Chosen balancing plane of the generator shaft end**

From these results it was also clear that the “usual” balancing planes at both ends of the generator rotor were not recommended to balance this present unbalance. However, from local inspections of the shaft end it became clear that it would be possible to do a balancing test run with a mass connected at the end of the shaft line on a rather non-conformistic plane (Figure 6). This plane would be the best location because the mode deformation is the highest at the shaft end. This location would also make the balancing plane easily accessible for further adjustment of the mass.

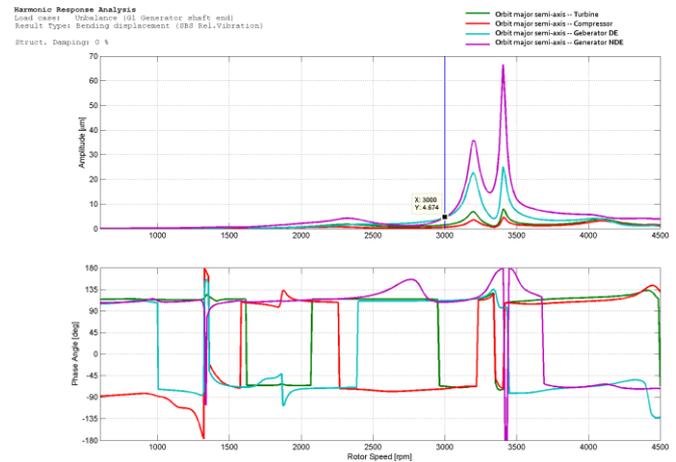
An unbalance calculation was done in order to have an idea of the expected response of the generator. The used weight for this calculation was determined by applying a G1 unbalance based on the weight of this free shaft end (Figure 7). This unbalance response shows that there is a certain influence at 50Hz due to this added unbalance, however to balance the shaft end, a correction mass of about 15x times

**Figure 7: Unbalance response of a G1 unbalance of the shaft end**

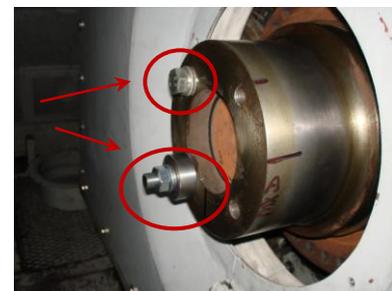
The necessary mass was added at the chosen shaft end (Figure 8) in order to determine the desired dynamic behaviour. Due to the relatively small rotor radius it was necessary to use a significant mass, otherwise the obtained influence would have been too low.

**Figure 8: Picture of the used balancing plane**

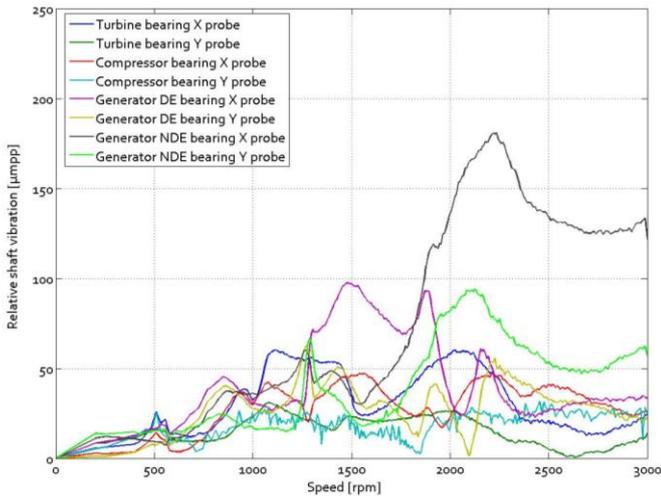
The resulting dynamic behaviour of the shaft line is shown in Figure 9 and shows that there is an important reduction of the relative shaft vibrations around 3000rpm. This confirms of course that this shaft end mode was the main reason for the increased shaft vibrations.

**Figure 9: Relative shaft vibration amplitudes after balancing**

A more detailed analysis of the vibration behaviour before and after the generator repair was made in the following days. This revealed that the influence of the unbalance distribution in the generator rotor before the repair partially compensated the impact of the shaft end unbalance on the vibration amplitude at operating speed. The modification of the generator rotor unbalance with the exchange of the fan blades created a situation where the unbalance distribution of both the rotor and the shaft end interacted in a negative way, thus causing high vibrations for the shaft end mode.

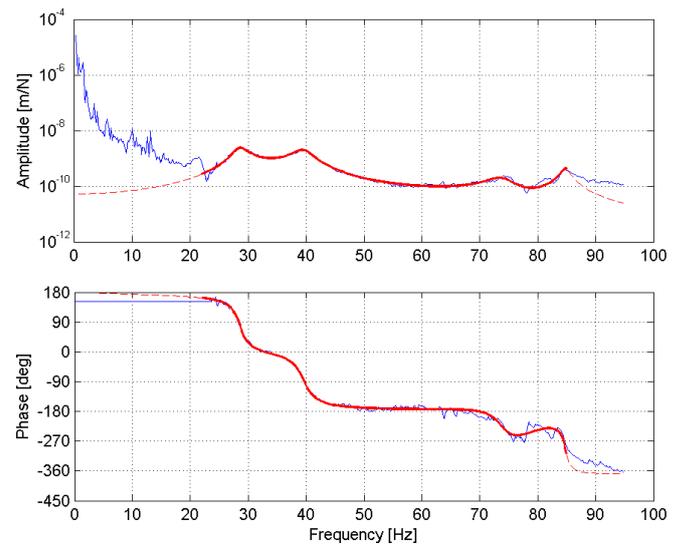
The different pedestal structures were modeled as pure mass and stiffness based on the impact tests on the bearings. For the modelling of the dynamic stiffness between the gas turbine compressor and turbine end bearing structure, a dynamic bearing support matrix was used [7,8]. Figure 11 shows the transfer function that has been used. The blue curve is the measured dynamic compliance in the vertical direction between the two gas turbine bearings, the red curve is the polynomial function that fits the measured curve. This polynomial curve is used to consider the influence of the support structure on the eigenvalues of the shaft line.

**Figure 11: Dynamic bearing support transfer function**

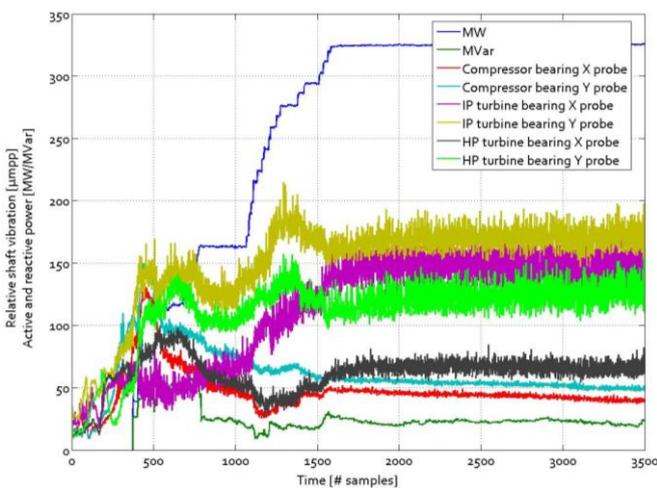
Figure 12 shows a typical plot for these kinds of phenomena, that have been observed on different units of the same type. It is clearly visible that all vibration amplitudes stabilize after a certain time but there is a visible influence of the load variation (active and reactive power) on the dynamic behaviour. The IP bearing vibrations attain the highest amplitudes, but the influence is also noticeable on the compressor and HP turbine bearing. The high vibration amplitudes can increase in many cases to values that are considered as unacceptable for long term operation, since they can be well above the B/C boundary of the ISO7919 standard.

Figure 12: Relative shaft vibration amplitudes for different load conditions

Bearing temperatures are not mentioned in Figure 12, but the compressor radial bearing was at full load at 113°C and the IP bearing at 71°C. Based on these values it seems that the compressor bearing is significantly higher loaded than the IP bearing.

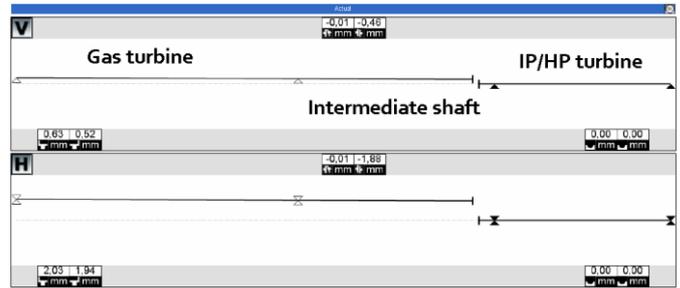
Alignment measurements with a Permalign system (Pruftechnik) have been done during operation in order to measure the movement of the gas turbine and IP/HP stator at different load points. It was found that these parts show a significant relative movement. Figure 13 shows the situation for a certain load point where a relative horizontal displacement of almost 2 mm has been measured when comparing to the cold alignment conditions. This has of course an important influence on the dynamic behaviour of

Figure 13: "Hot" alignment condition of the GT - IP/HP

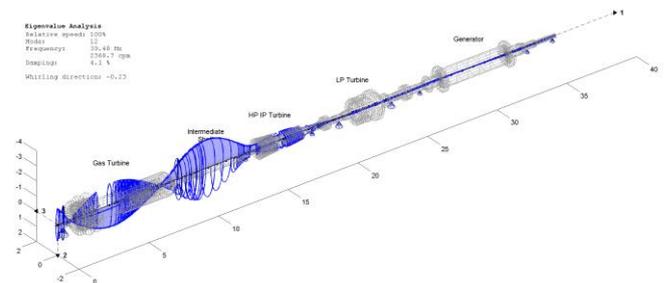
Figure 14: Mode shape of the 3<sup>rd</sup> vertical bending mode of the GT

The calculated critical speeds near the running speed of the shaft line of a properly aligned shaft line are displayed in Figure 14-16. Based on this calculation it was possible to select the natural modes that have an influence on the behaviour of the unit at operating speed (50Hz):

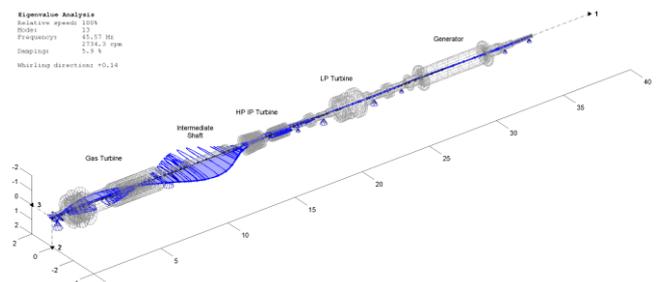
Figure 15: Mode shape of the 3<sup>rd</sup> horizontal bending mode of the GT

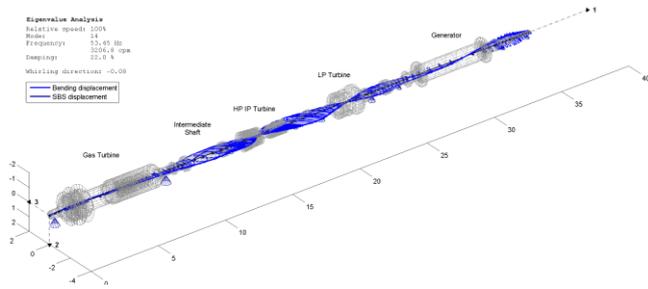
**Figure 16: Mode shape of the 2<sup>nd</sup> horizontal bending mode of the IP/HP turbine**

shows that only cases 4 and 5 have an important influence on the 2<sup>nd</sup> horizontal bending mode of the IP/HP rotor. For case 4 this is done by influencing the damping factor, for case 5 this is by both a frequency decrease and a damping reduction. It is therefore most likely that the 2<sup>nd</sup> horizontal bending mode of the IP/HP rotor is responsible for the increased shaft vibrations near the IP bearing although the influence visible in the HP bearing doesn't correspond with the response of the model. The misalignment values used in case 5 are significantly higher than those found with the Permalign measurement but the study shows nevertheless that alignment deteriorations can alter the behaviour at nominal speed significantly.

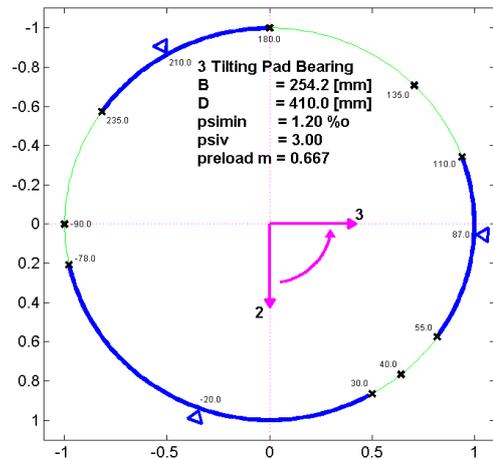
**Figure 17: HP/IP bearing geometry**

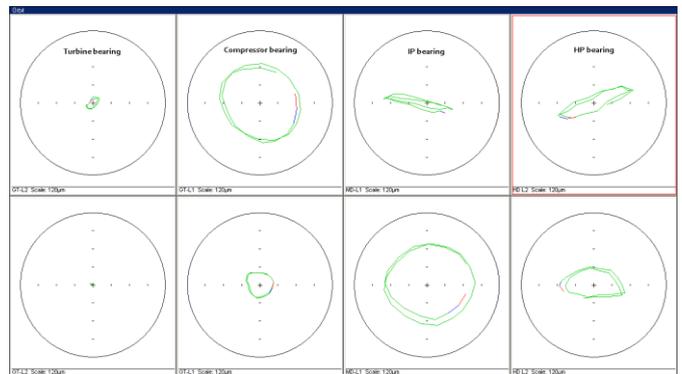
This change in dynamic stiffness in these bearings is also visible in the orbit plots at different load conditions of the unit (Figure 18). At lower loads the compressor end bearing of the gas turbine shows a circular orbit which means that the bearing is behaving isotropic. This is reasonable because this bearing is a four tilted pad bearing with the load between the pads. The vertical and horizontal stiffness are equal and thus an isotropic behaviour can be expected. The IP bearing on the contrary shows a more elliptical orbit shape at lower loads which means that the bearing is behaving non-isotropic. This

However when the load increases, the orbit shape for the compressor end bearing becomes smaller while the IP bearing becomes circular. This indicates that the bearing behaves isotropic, which can only be caused by a different shaft position within the bearing and thus a different vertical and horizontal bearing stiffness.

**Figure 18: Orbit plots at different load conditions (up 110MW ; down 330MW)**
